## PROPERTY CONDITION REPORT

**ADDISON AIRPORT HANGARS A1 AND A1A**  
4726 and 4730 George Haddaway Drive  
Addison, Texas 75001

Date: May 18, 2012  
Partner Project No. 12-86801.1

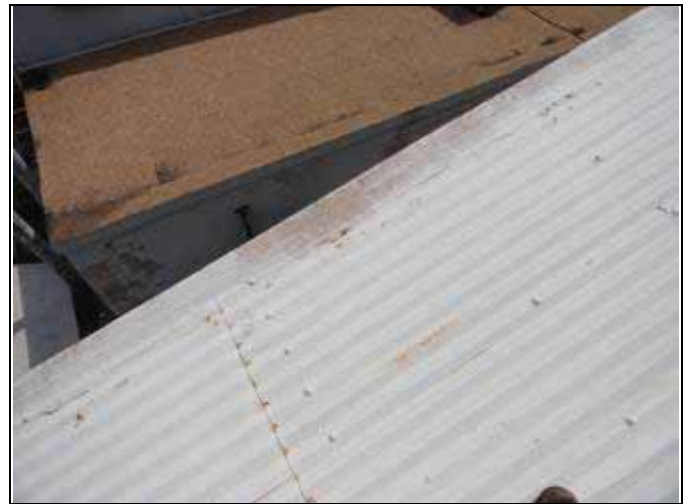
16. Edge condition at roofs

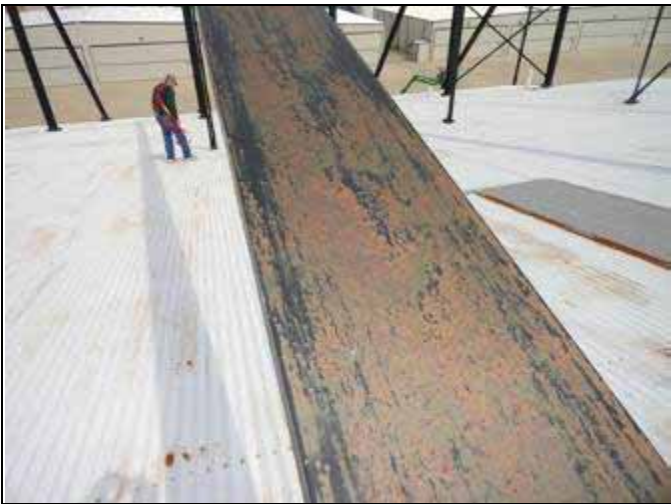
57. Surface corrosion at exposed roof structure

4.2	Truss	1680	LF	\$12	\$20,160	Remove corrosion and apply rust inhibitor to truss chords
4.2	Mezzanine framing	1	LS	\$15,000	\$15,000	Repair mezzanine framing

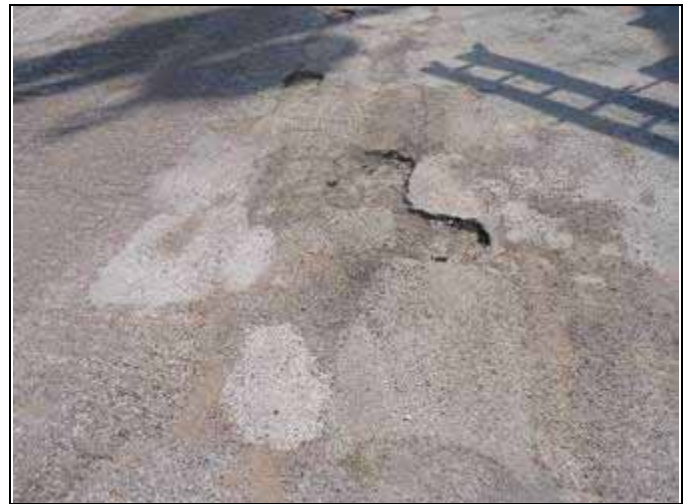
58. Paving damage at George Haddaway Drive

SECT. #	ITEM	QTY	UNIT	UNIT COST	TOTAL COST	CONDITION
<b>SITE IMPROVEMENTS</b>						
3.3	Vehicle paving	12,250	SF	\$2.50	\$30,625	Repair and overlay George Haddaway Drive behind the buildings

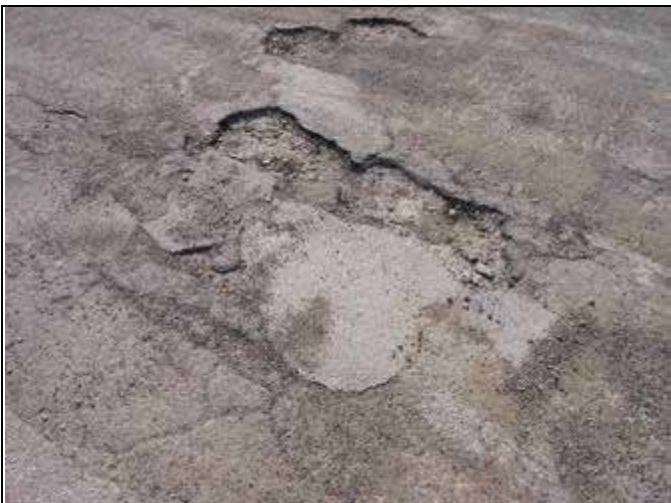
59. Pavement damage at George Haddaway Drive

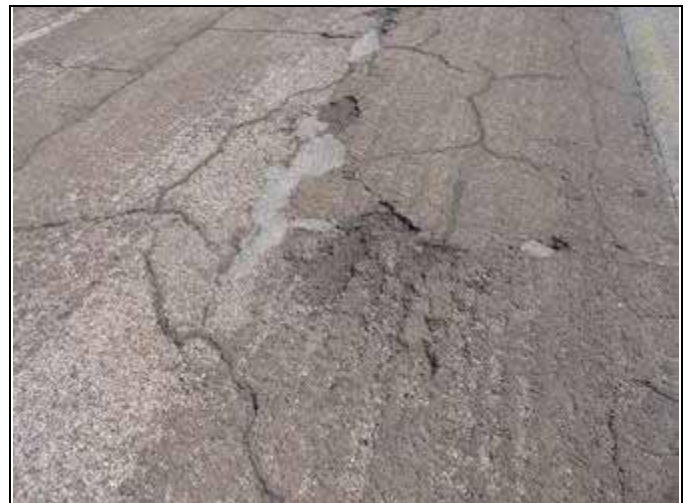
60. Pavement damage at south apron

3.3	Apron paving	28,000	SF	\$8.50	\$238,000	Replace damaged asphalt paving with FAA-compliant concrete paving
<b>BUILDING ENVELOPE</b>						
4.1	Slab grinding	1	LS	\$1,500	\$1,500	One area of slab movement was observed

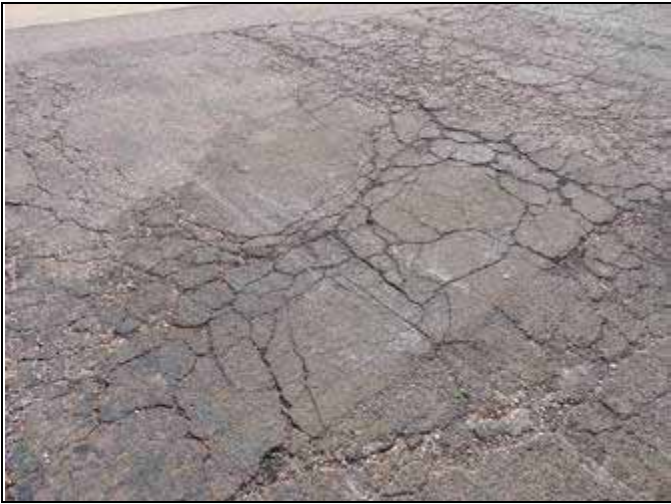
61. Pavement damage at south apron

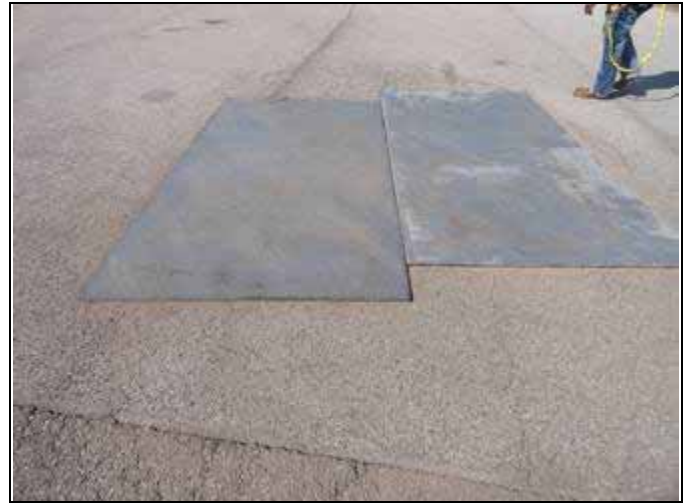
62. Steel plates set over pavement void at south apron

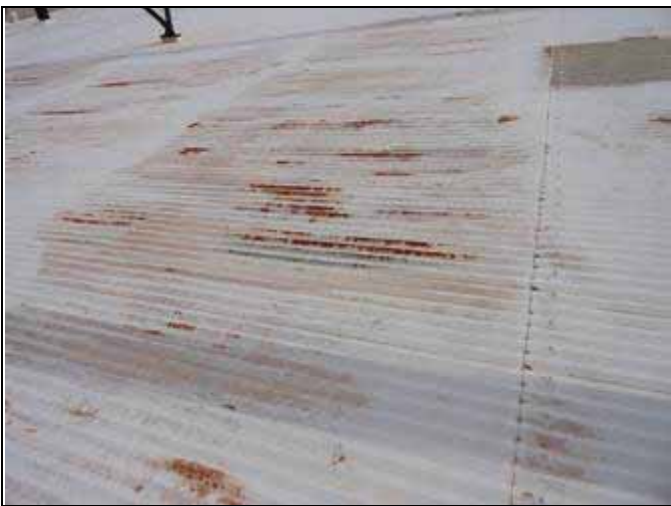
63. Roofing panel corrosion

4.3	Hangar roofing	61,000	SF	\$9.00	\$549,000	Replace the original, deteriorating steel roofing panels over the hangars
4.4	Exterior walls	49,574	SF	\$1.25	\$61,968	Paint exterior walls and perform repairs to damaged areas and sealant

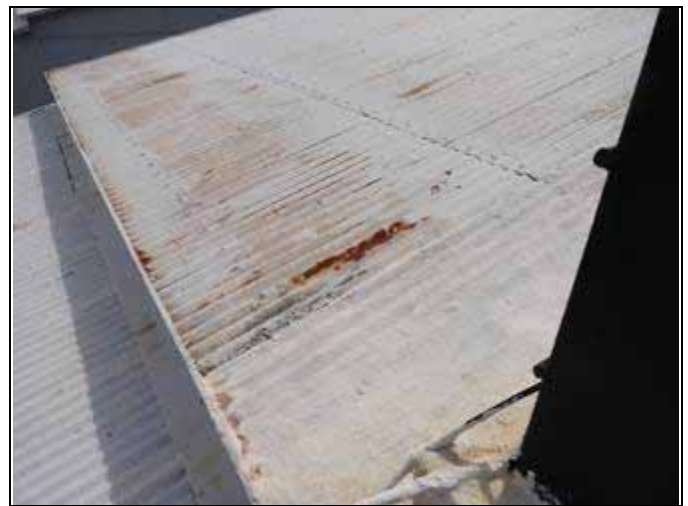
64. Roofing panel corrosion

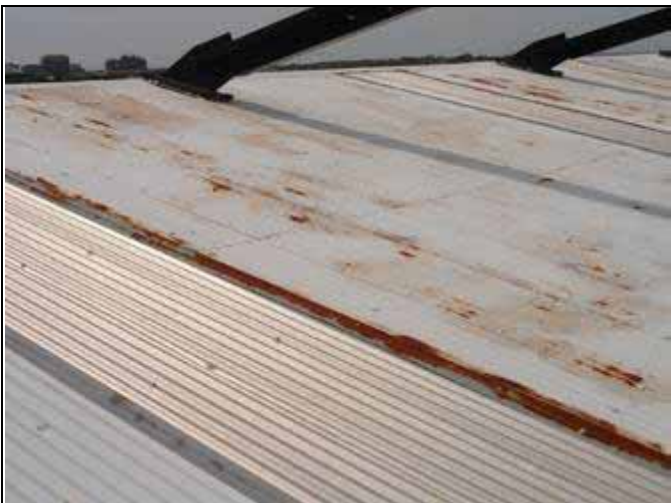
65. Roofing panel corrosion

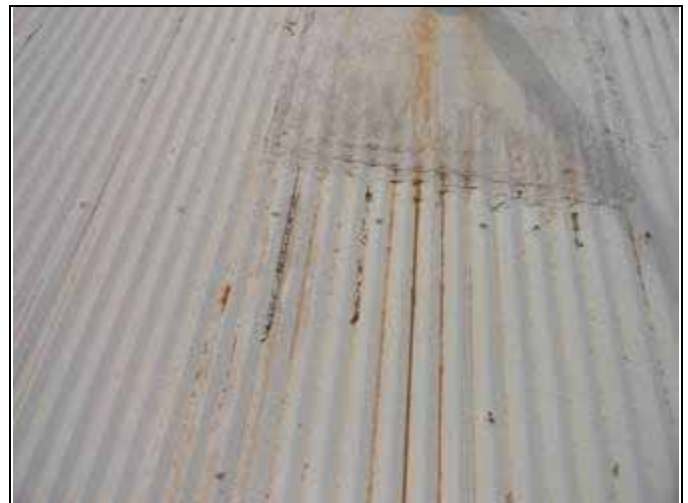
66. Roofing panel corrosion and deteriorated finish

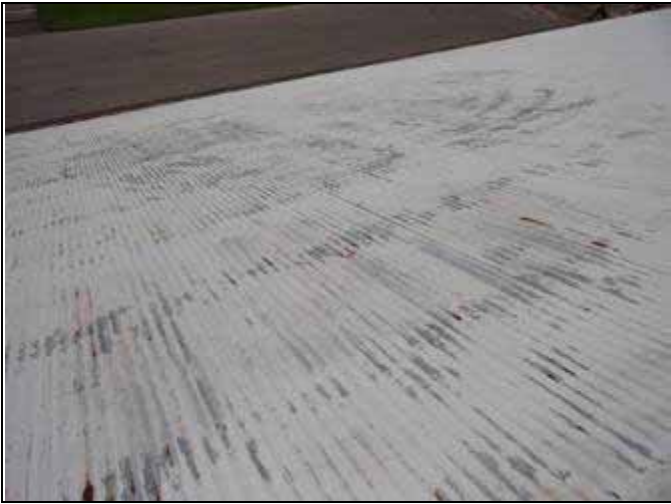
67. Deteriorated finish on roofing panels

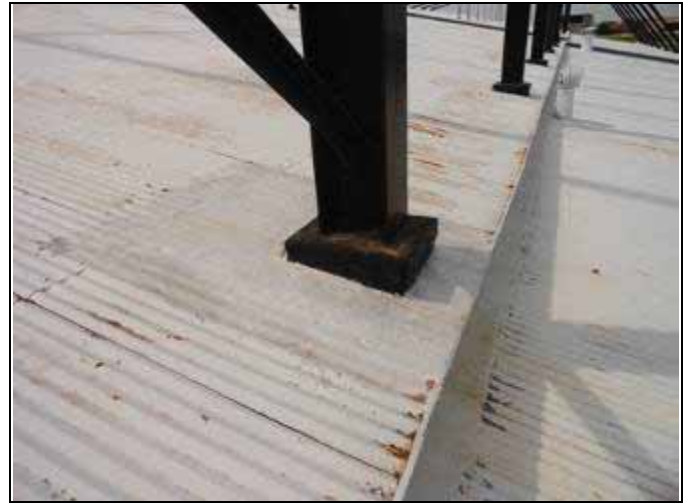
68. Repaired flashing at structural penetration

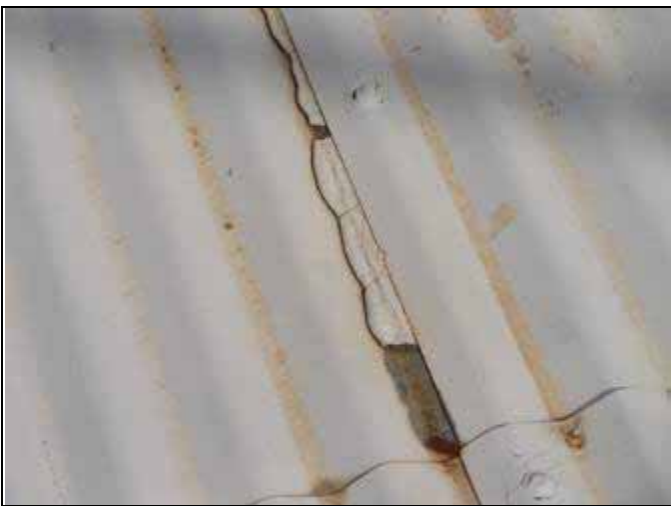
69. Deteriorated sealant and roofing panel joint

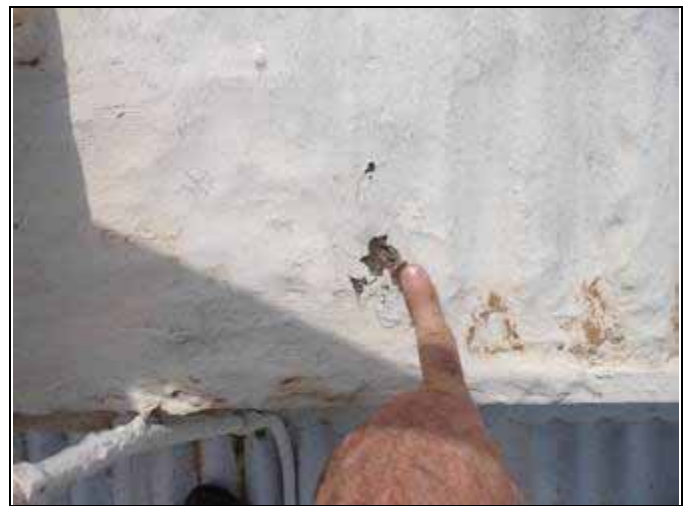
70. Deteriorate fabric of prior roofing repairs

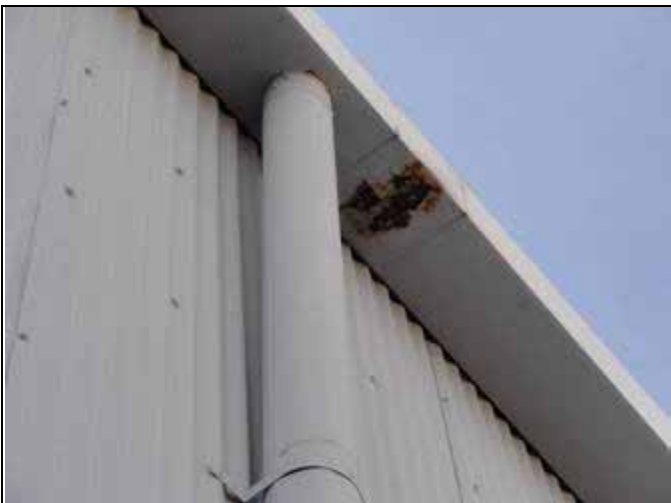
71. Corroded roof gutter

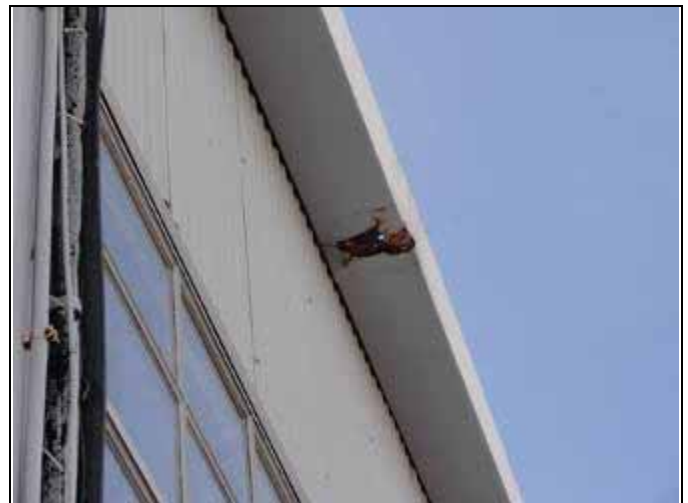
72. Corroded roof gutter

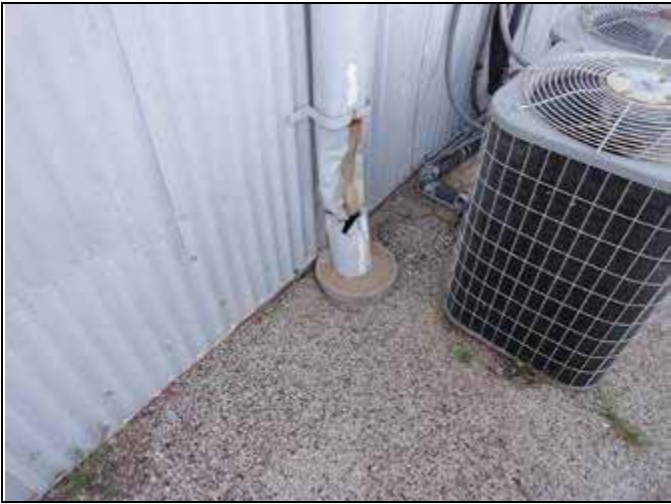
73. Damaged roof downspout

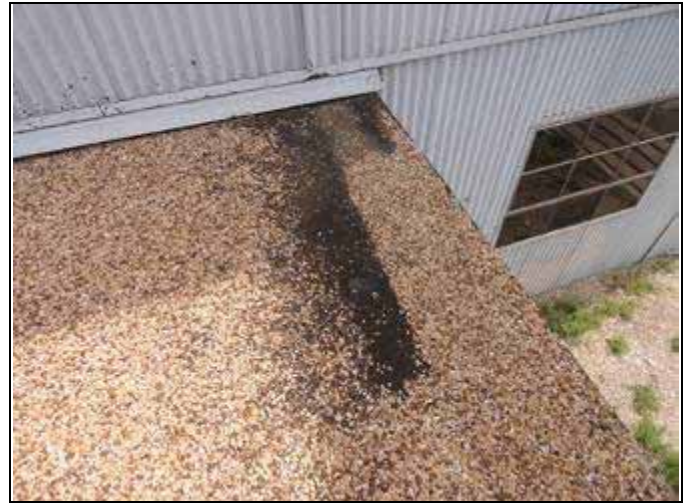
74. Displaced built-up aggregate and cracking bitumen

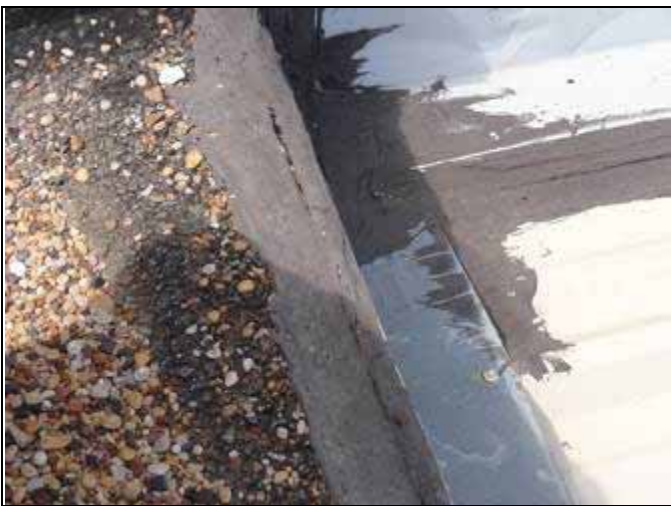
75. Split bitumen at built-up roofing

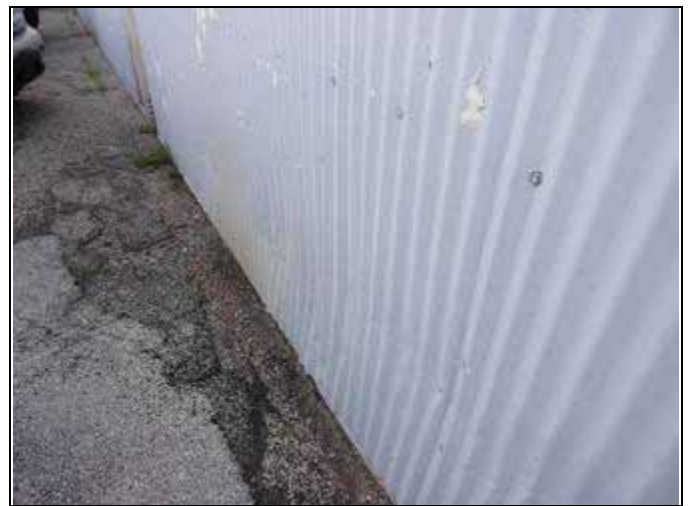
76. Impact damaged wall panels

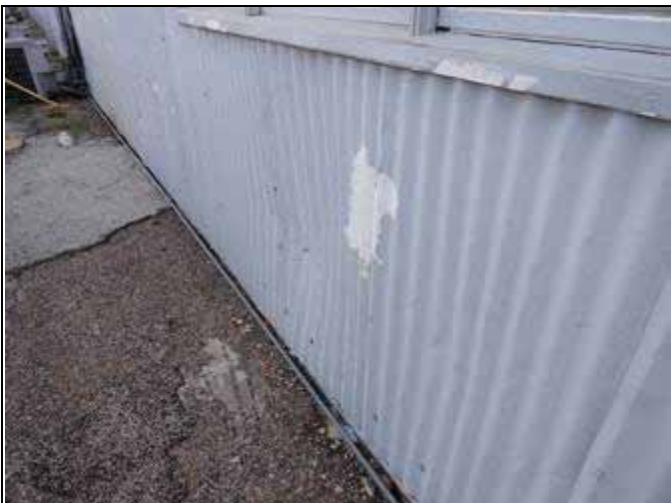
77. Impact damaged wall panels

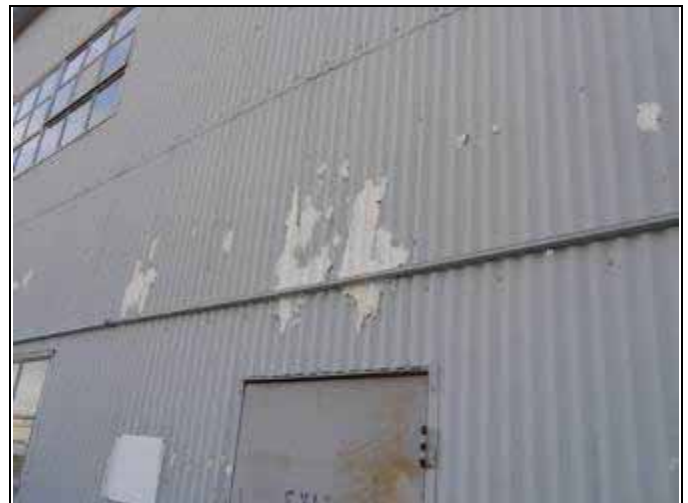
78. Peeling paint on wall panels

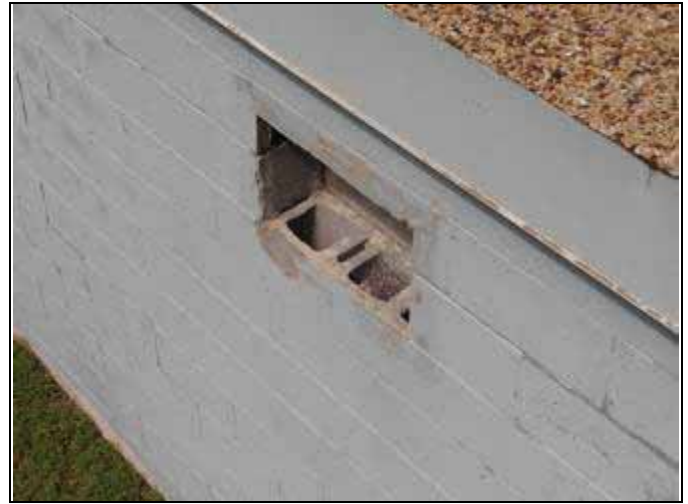
80. Damaged CMU wall at addition

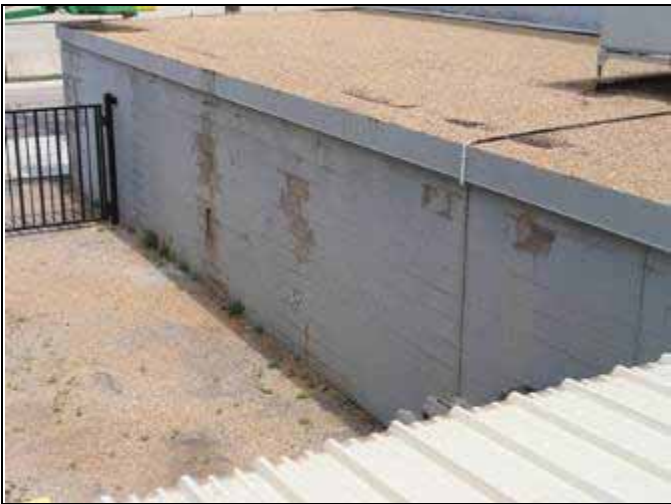
81. Peeling paint at addition

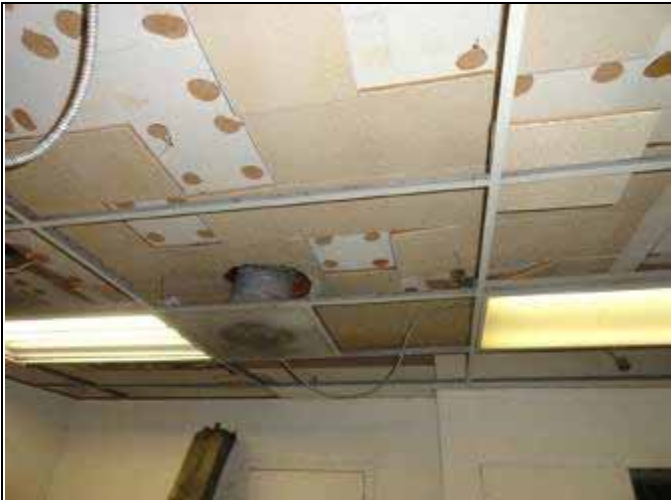
83. Damaged interior finishes

6.2	Interior walls	18,750	SF	\$0.65	\$12,188	Paint the worn interior walls and repair isolated areas of damage
6.2	Ceilings	2	LS	\$5,000	\$10,000	Remove all ceiling systems to structure

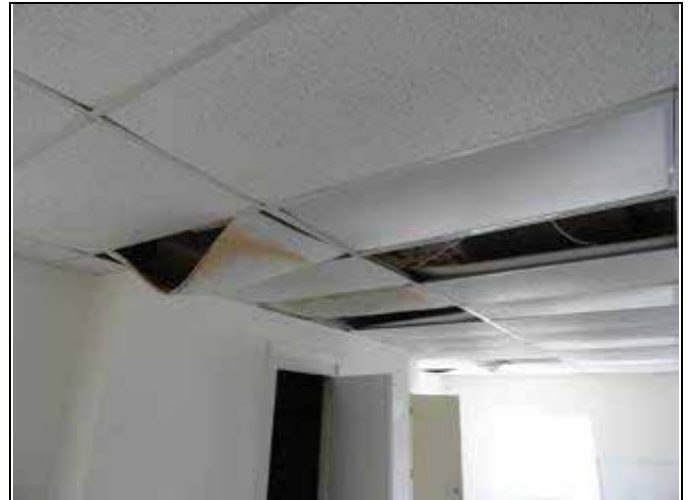
84. Damaged interior finishes

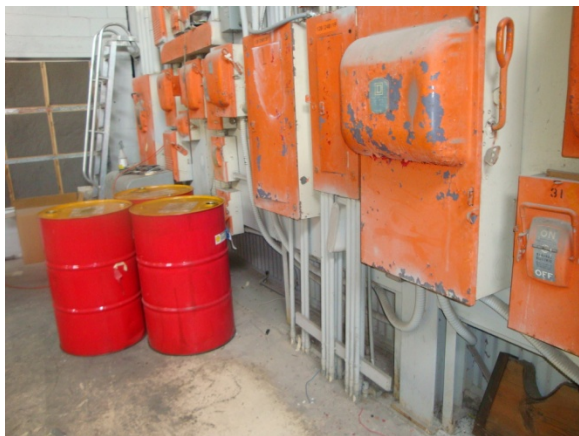
44. Domestic water heater

45. Main electrical distribution center
