## PROPERTY CONDITION REPORT

**ADDISON AIRPORT HANGARS A1 AND A1A**  
4726 and 4730 George Haddaway Drive  
Addison, Texas 75001

Date: May 18, 2012  
Partner Project No. 12-86801.1

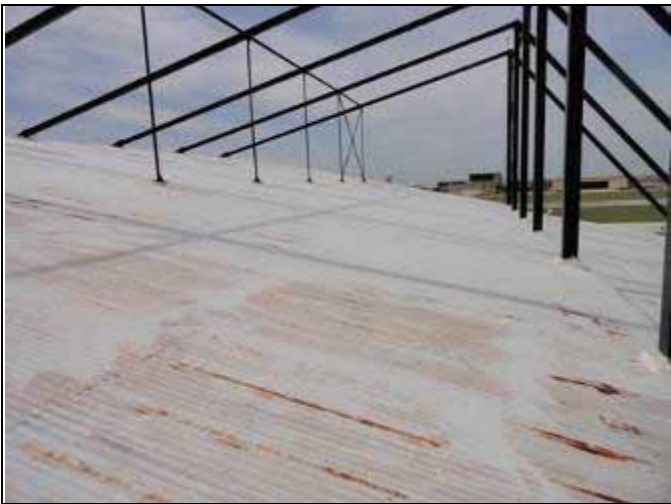
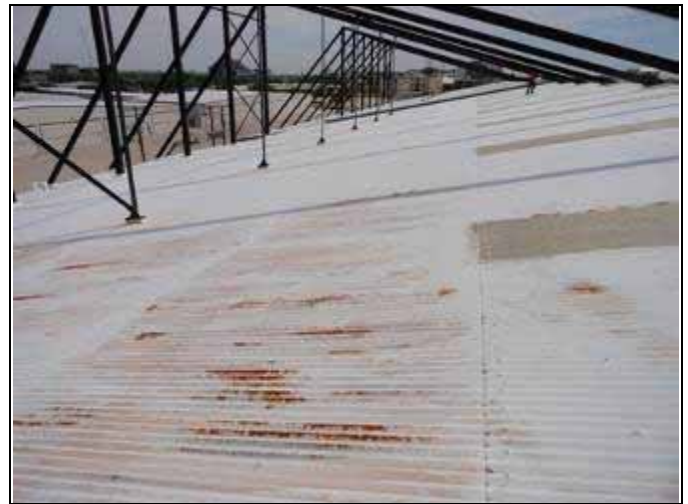
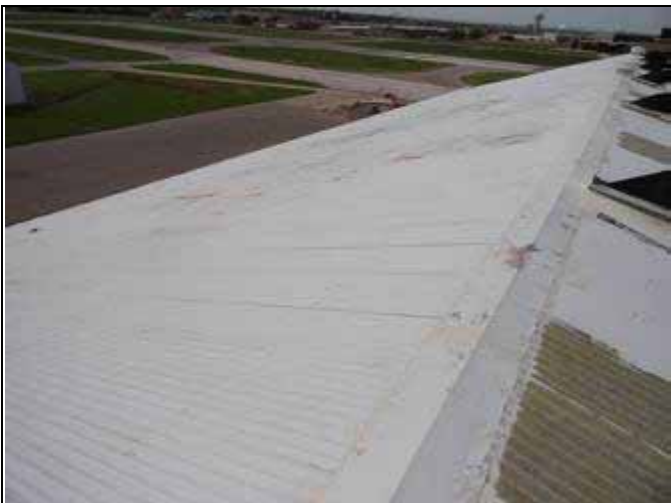
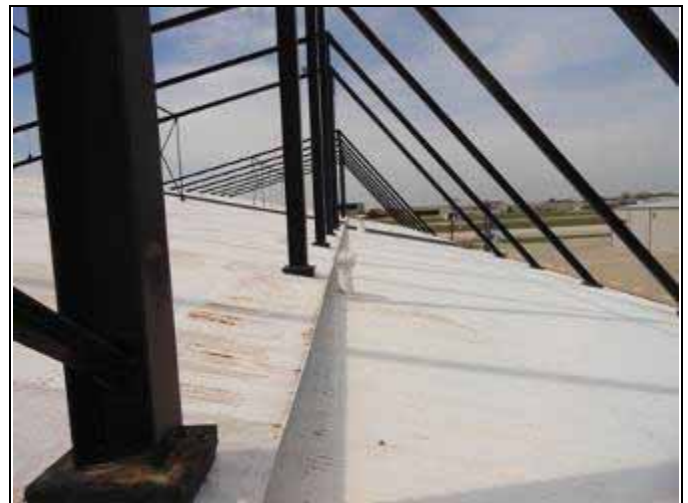
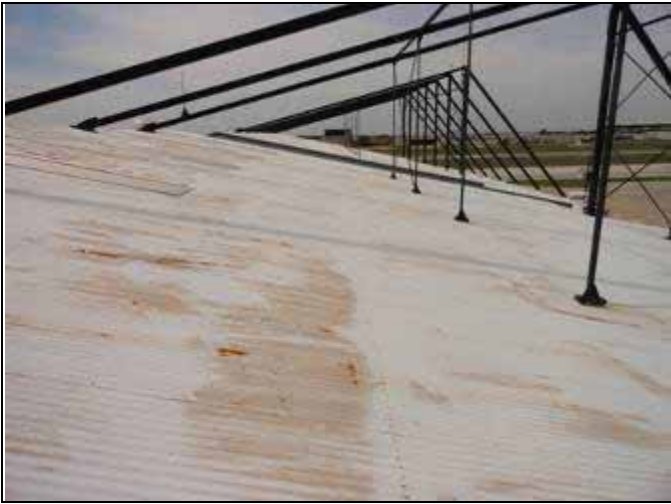
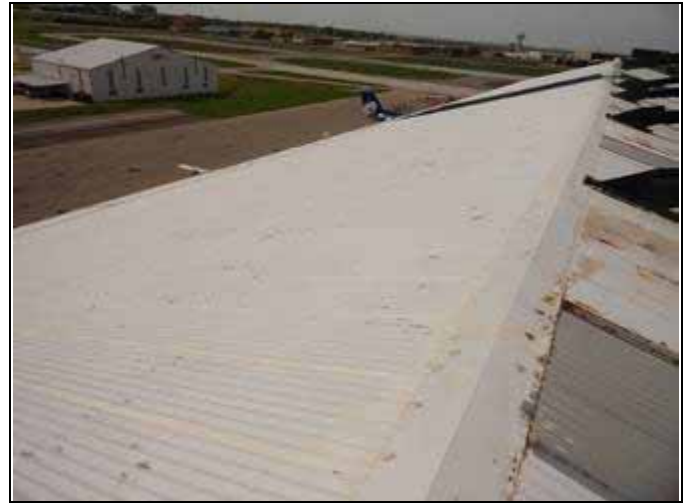
- The original hangar roofing panels show extensive signs of corrosion, repairs are substantial and repair efforts have realized their effectiveness as well,

9. North roof at 4726

10. North roof at 4726

11. South roof at 4726

12. North roof at 4730

13. North roof at 4730

14. South roof at 4730

4.3	Hangar roofing	61,000	SF	\$9.00	\$549,000	Replace the original, deteriorating steel roofing panels over the hangars
4.4	Exterior walls	49,574	SF	\$1.25	\$61,968	Paint exterior walls and perform repairs to damaged areas and sealant

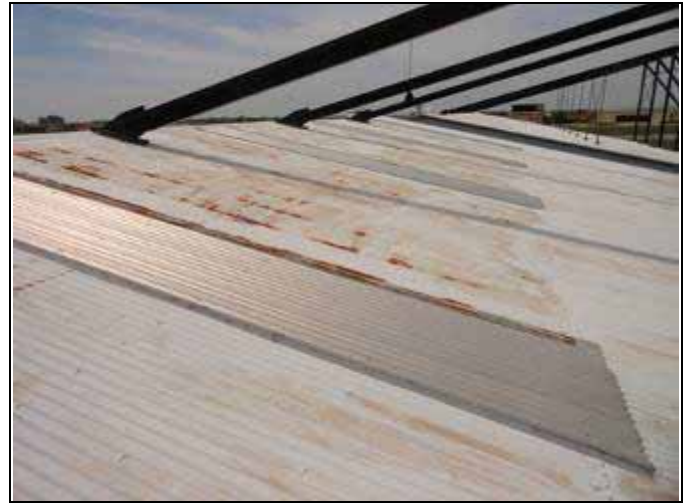
20. Skylight replacement panel at 4730

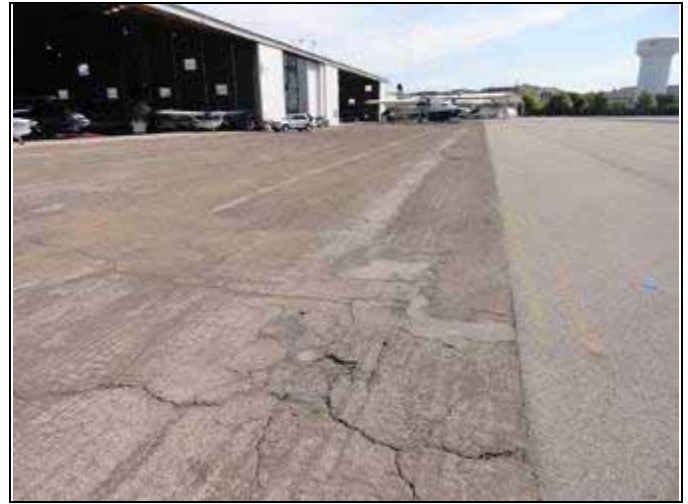
26. Tarmac paving south of buildings

- Vehicle paving at the end of George Haddaway Drive as well as paving at the front apron of the hangars is damaged,
- An area of displaced slab was observed,

3.3	Apron paving	28,000	SF	\$8.50	\$238,000	Replace damaged asphalt paving with FAA-compliant concrete paving
<b>BUILDING ENVELOPE</b>						
4.1	Slab grinding	1	LS	\$1,500	\$1,500	One area of slab movement was observed

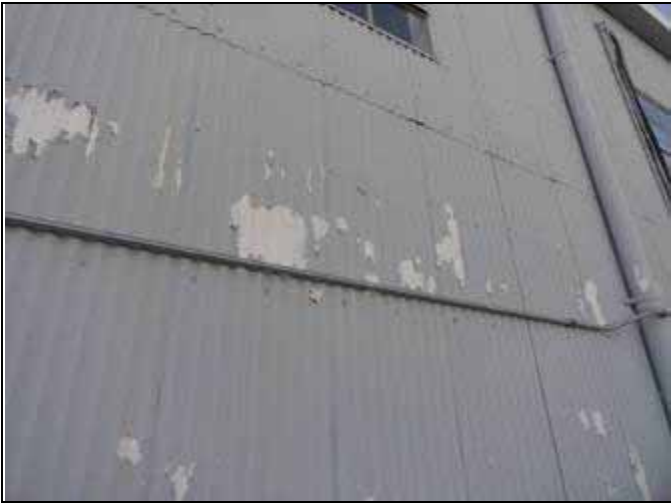
78. Peeling paint on wall panels

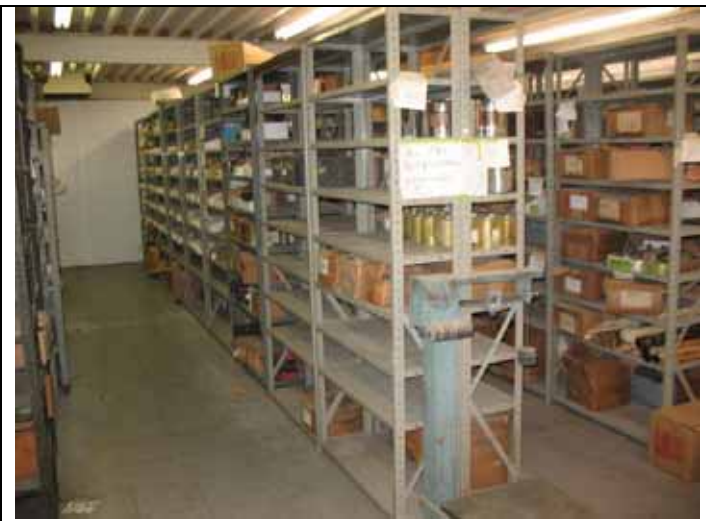
5. View of west side storage area with ACBM floor tile/mastic.

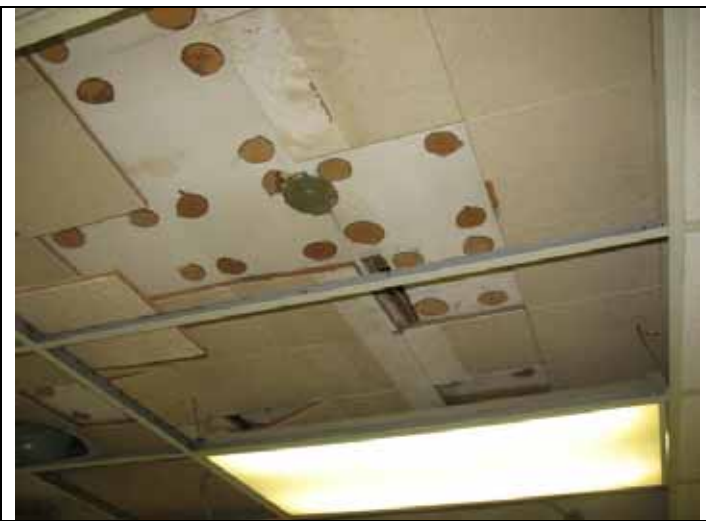
7. View of ACBM mastic on ceiling in NE office area of east hanger.

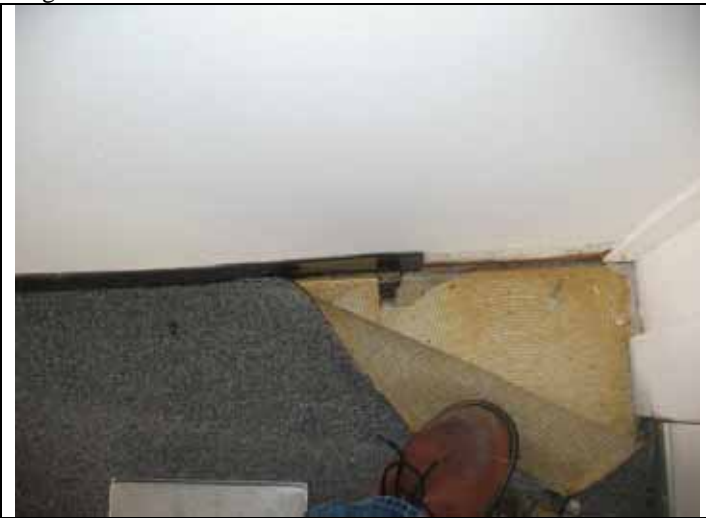
9. View of ACBM tile under non-ACBM tile, under carpet on 2<sup>nd</sup> floor of NE office area of east hanger.

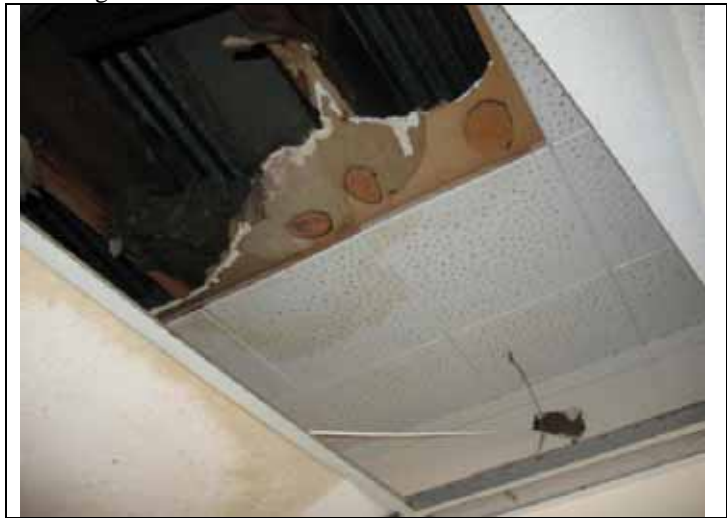
10. View of ACBM ceiling mastic in 2<sup>nd</sup> floor room above NE office area in east hanger.

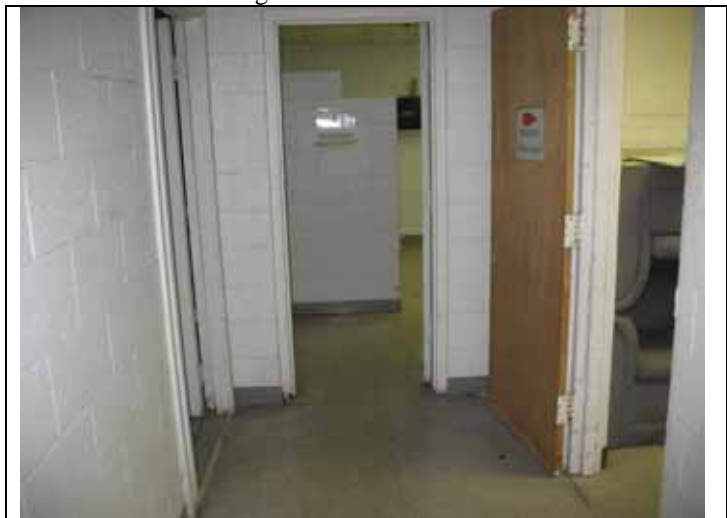
12. View of ACBM floor tile/mastic in 1<sup>st</sup> floor room in NE Office area of east hanger

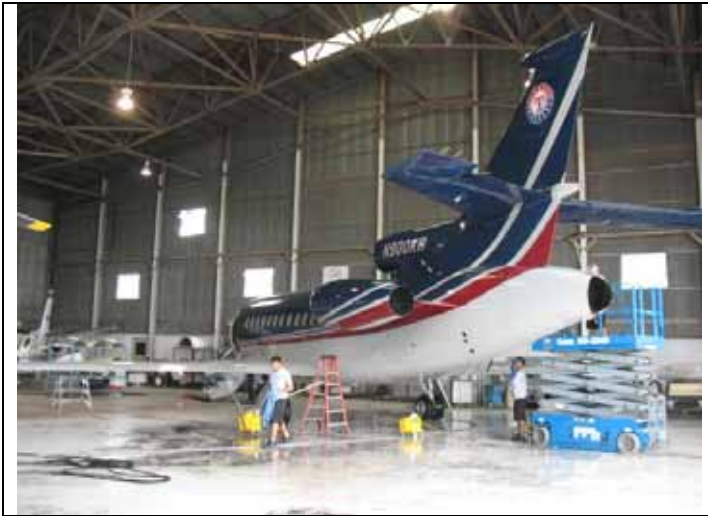
13. View of south interior of west hanger

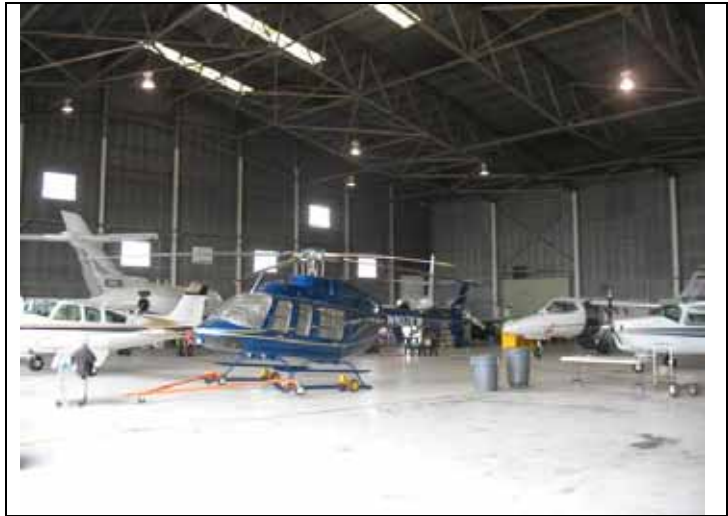
14. View of north interior of west hanger.

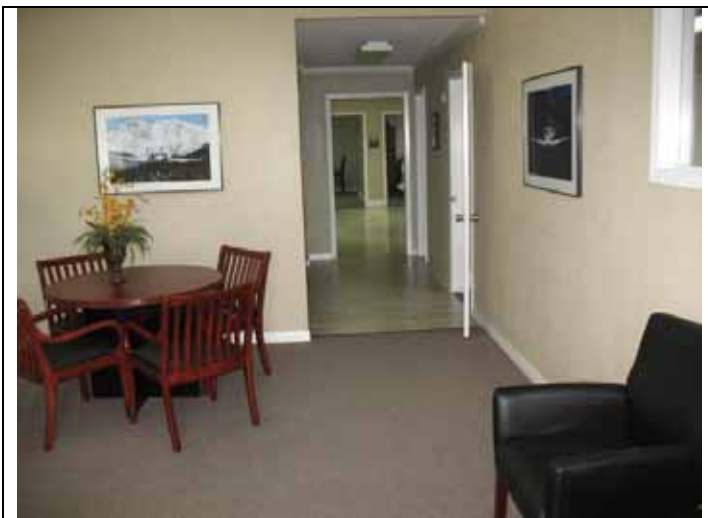
15. View of front reception area of west hanger

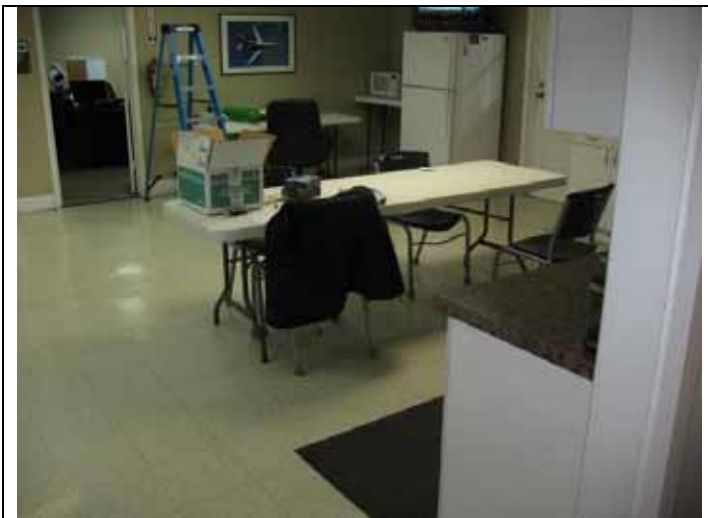
17. View of break room.

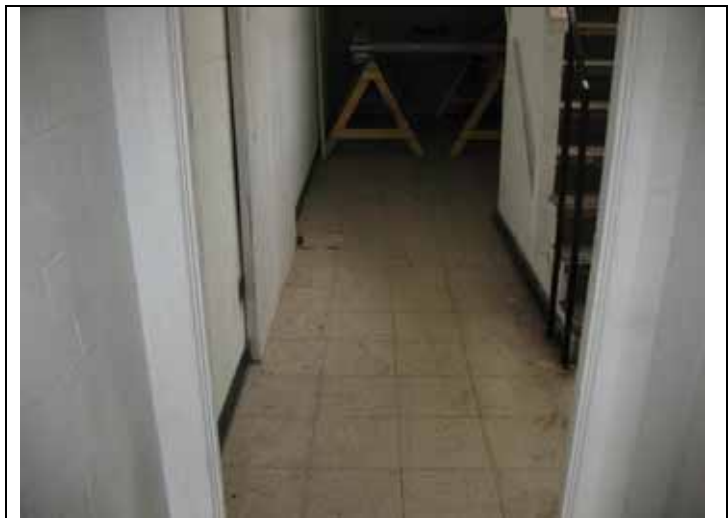
18. View of connecting hallway.

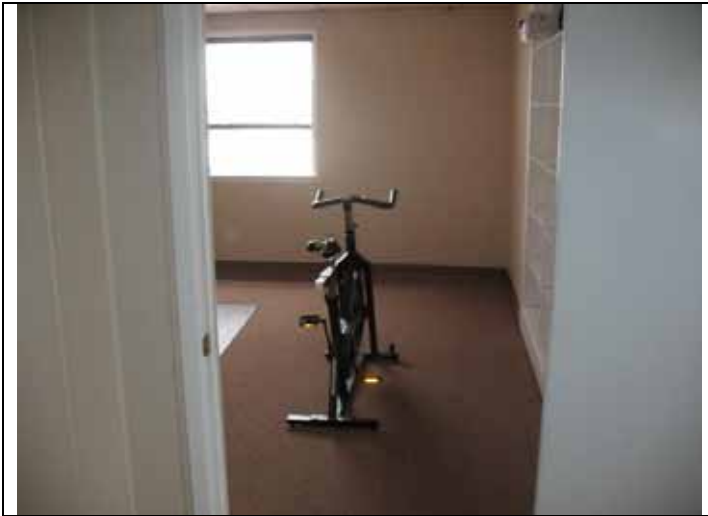
19. View of second floor room in west hanger.

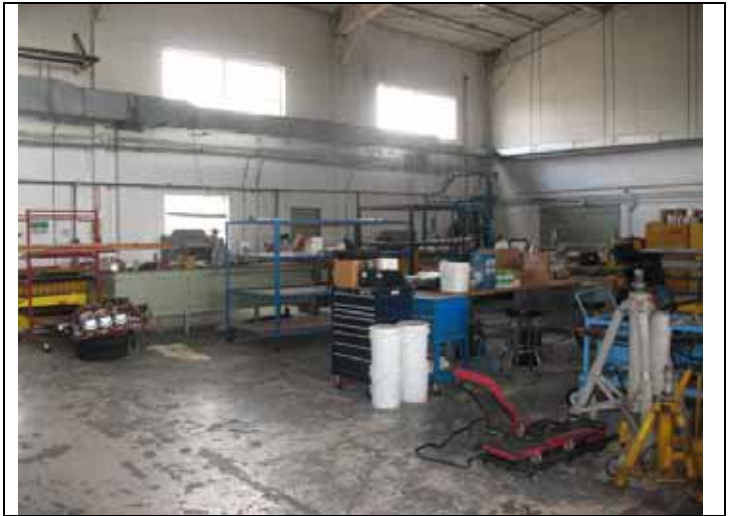
20. View of north work room area in west hanger.

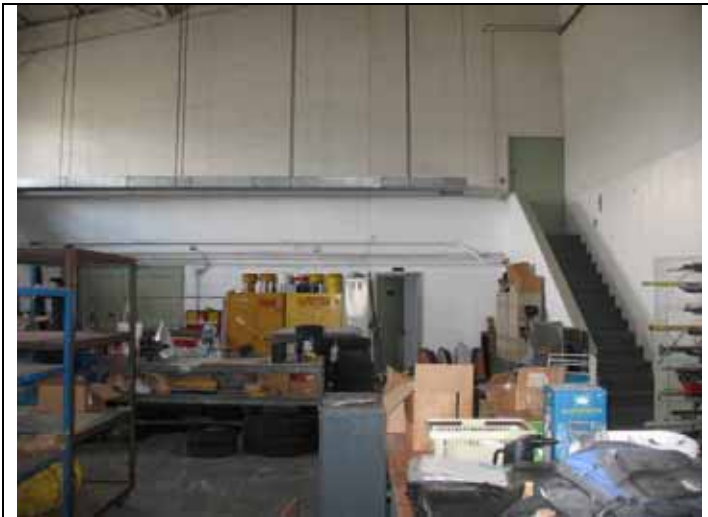
21. View to the west across the north work room area of the west hanger

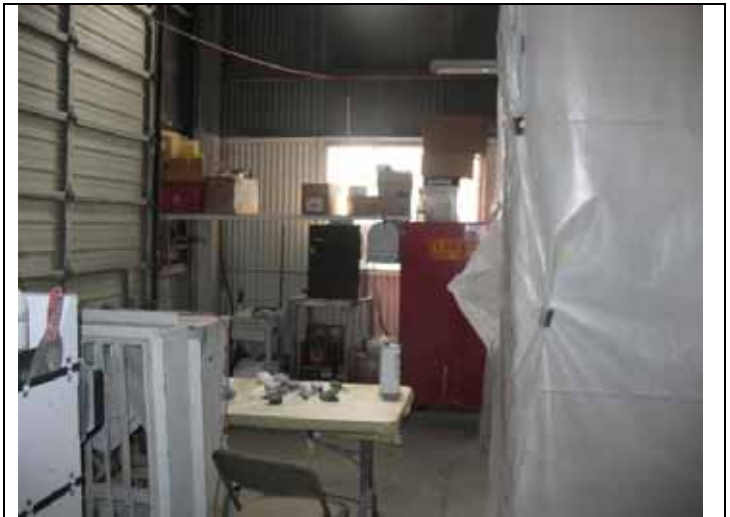
22. View of paint room in NE area of west hanger.

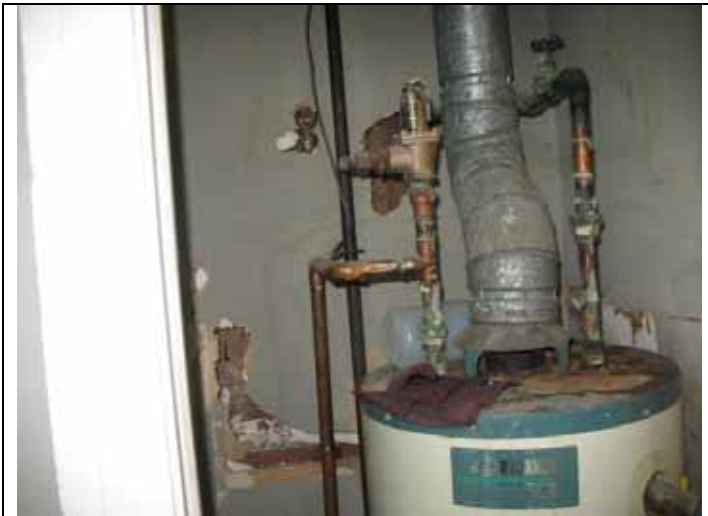
23. View of water heater in NE restroom of west hanger.

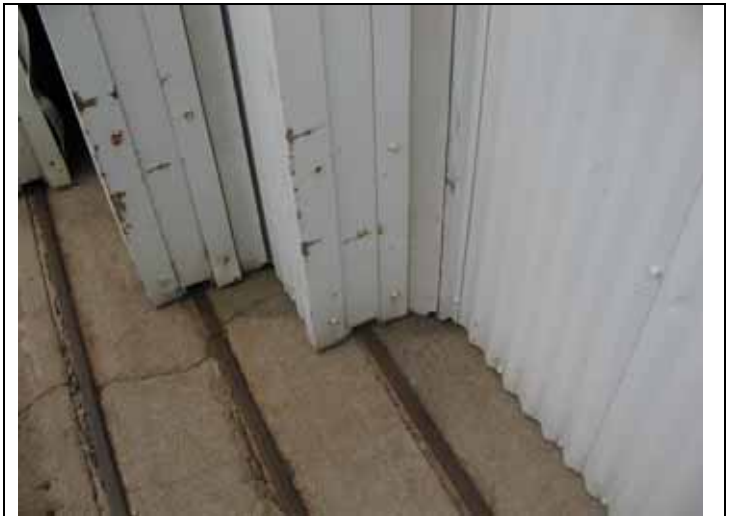
24. View of door gaskets on south hanger doors of west hanger.
