## PROPERTY CONDITION REPORT

**ADDISON AIRPORT HANGARS A1 AND A1A**  
4726 and 4730 George Haddaway Drive  
Addison, Texas 75001

Date: May 18, 2012  
Partner Project No. 12-86801.1

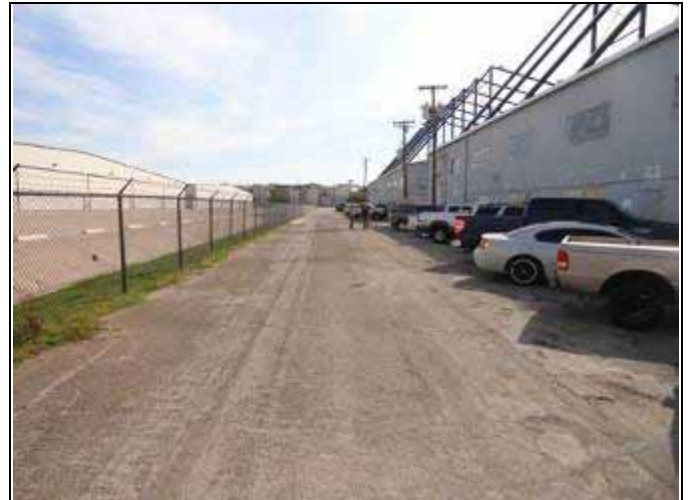
24. George Haddaway Drive north of buildings

- Vehicle paving at the end of George Haddaway Drive as well as paving at the front apron of the hangars is damaged,
- An area of displaced slab was observed,

SECT. #	ITEM	QTY	UNIT	UNIT COST	TOTAL COST	CONDITION
<b>SITE IMPROVEMENTS</b>						
3.3	Vehicle paving	12,250	SF	\$2.50	\$30,625	Repair and overlay George Haddaway Drive behind the buildings

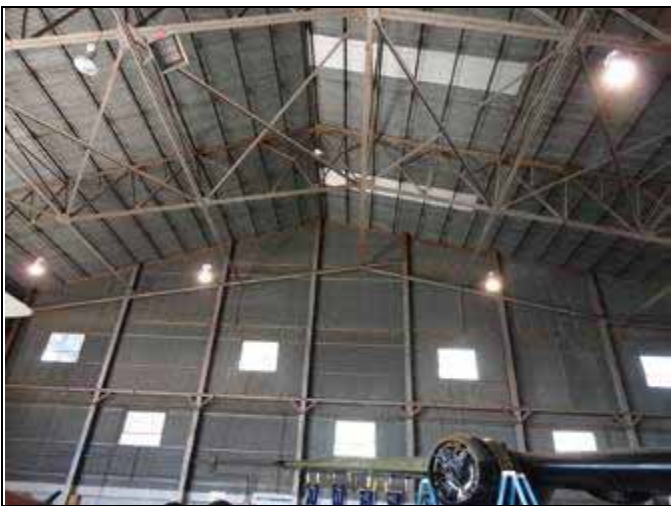
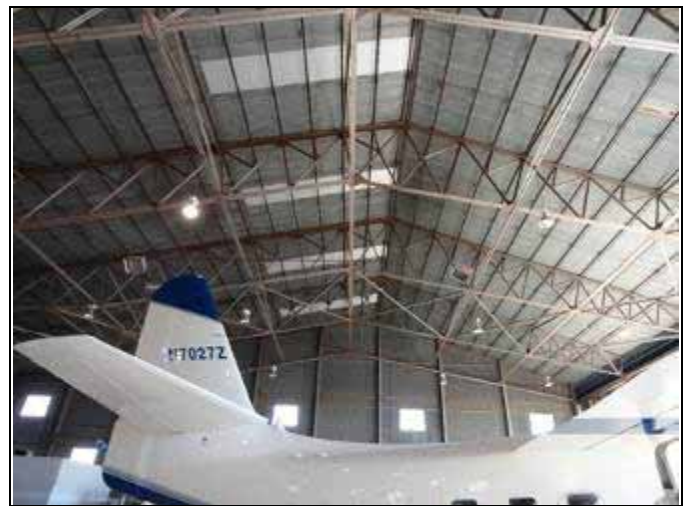
27. Hangar structure

28. Hangar structure

4.2	Truss	1680	LF	\$12	\$20,160	Remove corrosion and apply rust inhibitor to truss chords
4.2	Mezzanine framing	1	LS	\$15,000	\$15,000	Repair mezzanine framing

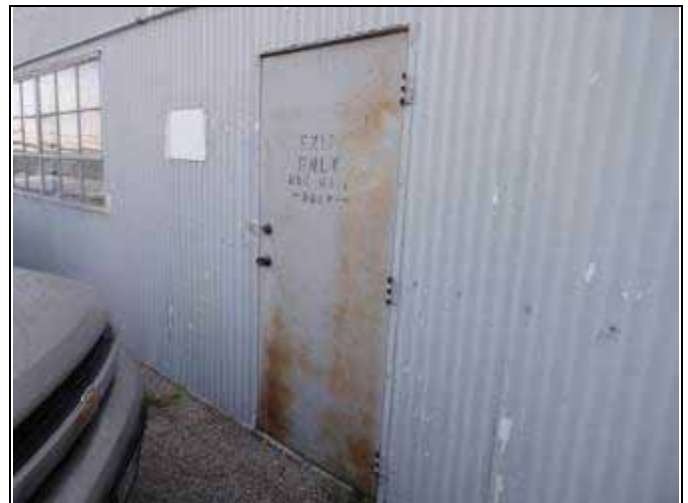
36. Service door

- Exterior walls have excessive peeling paint and areas of impact damage,
- Windows have broken panes and glazing seals which are deteriorating,
- Hangar and man-doors show extended age with miscellaneous areas of damage and/or operation that is not optimal,

4.4	Windows	2	LS	\$3,500	\$7,000	Replace damaged panes, reseal glazing and service operable components
4.4	Doors	2	LS	\$2,500	\$5,000	Service all hangar doors and man-doors to ensure proper operation

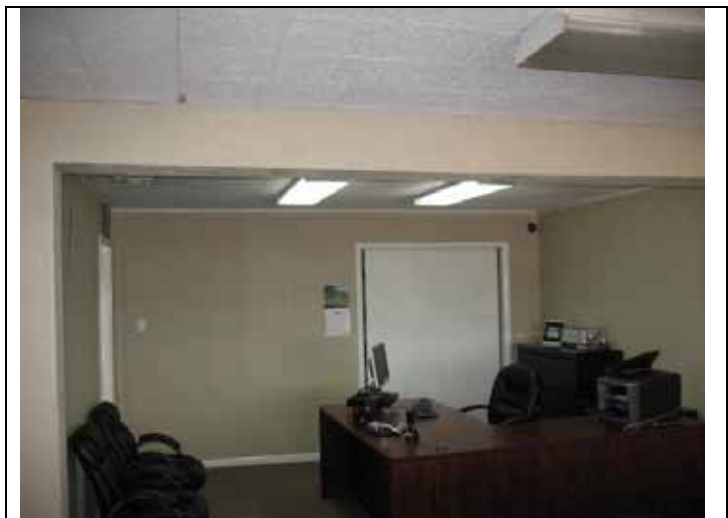
16. View of office in west hanger.

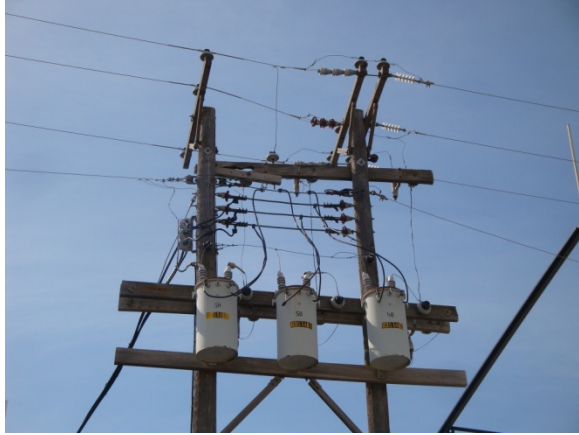
**Photo Exhibit #1**

On the outside of the structure, at the northwest corner, there is a set of three 50 KVA pole-mounted utility transformers which take high voltage service from the utility company overhead lines and step it down to 208Y/120V-3PH, 4W service (Photo Exhibit #1). The utility feeders are routed overhead at the north side of the building and originate from a point near Addison Road. The service cables route from the utility pole, through an exterior weather-head and into the building. The building electrical service enters the building from overhead via two (2) 4-inch conduits and two (2) 3-inch conduits through the west wall. The two (2) 4-inch conduits terminate into a surface mounted wireway which feeds four separate disconnect switches of various sizes ranging from 100A to 400A. The two (2) 3-inch conduits terminate into a 400A service rated disconnect switch. Each service switch feeds a variety of panel boards, disconnect switches and miscellaneous equipment (Photo Exhibit #2). The total capacity that this system is capable of delivering is approximately 6 watts per square-foot. Refer to drawing #1 at the end of this report for a schematic riser diagram of the electrical system.

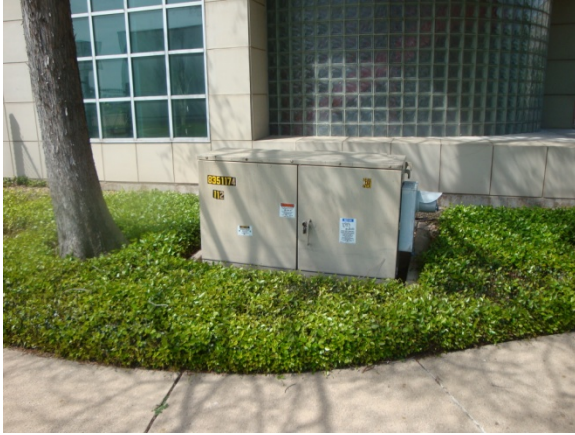
**Photo Exhibit #10**

The building is served from a pad mounted utility transformer located at the southeast corner of the building. It appears the transformer is rated at 112.5 KVA (Photo Exhibit #10). The transformer is fed on the primary side by a high voltage utility line that drops down a riser pole (Photo Exhibit #11). The feeders route below grade from the riser pole to the pad mounted transformer. From the transformer, it appears the secondary service conductors route underground below the building to a location where they rise vertically within the exterior wall and then terminate into wireway located in the main electrical room. The main electrical room is located on the second floor. There are five (5) panels directly tapped from the wireway feeders that comprise the building's electrical system (Photo Exhibit # 12 & #13). The current electrical utility infrastructure will allow for approximately 14 watts per square-foot. Refer to drawing #3 at the end of this report for a schematic riser diagram of the electrical system.

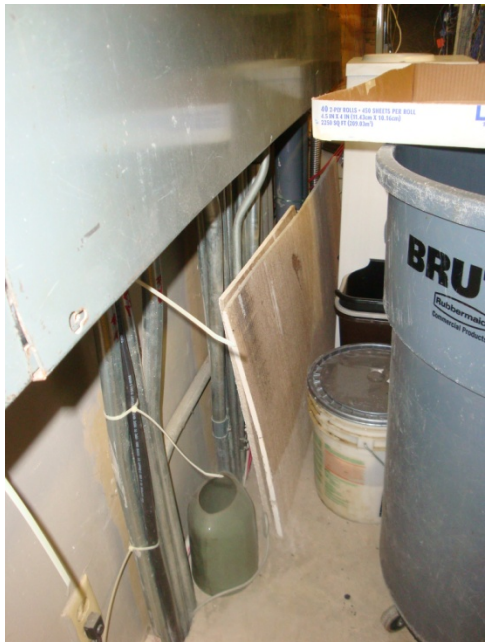
**Photo Exhibit #14**

Again, we noted several equipment areas that did not provide the minimum required working clearances as outlined in the National Electrical Code Article 110 (Photo Exhibit #14). Refer to East Hangar description for clearance requirements. We recommend providing tape marking on the floor to indicate this required working clearance. No objects can be stored within this projected area.
